**LIMITED PHASE I  
ENVIRONMENTAL SITE ASSESSMENT  
MITCHELL FIELD  
ROUTE 123  
HARPSWELL, MAINE**

Prepared by:  
SUMMIT ENVIRONMENTAL CONSULTANTS, Inc.  
640 Main Street  
Lewiston, Maine 04240

August 21, 2006  
Project #6971

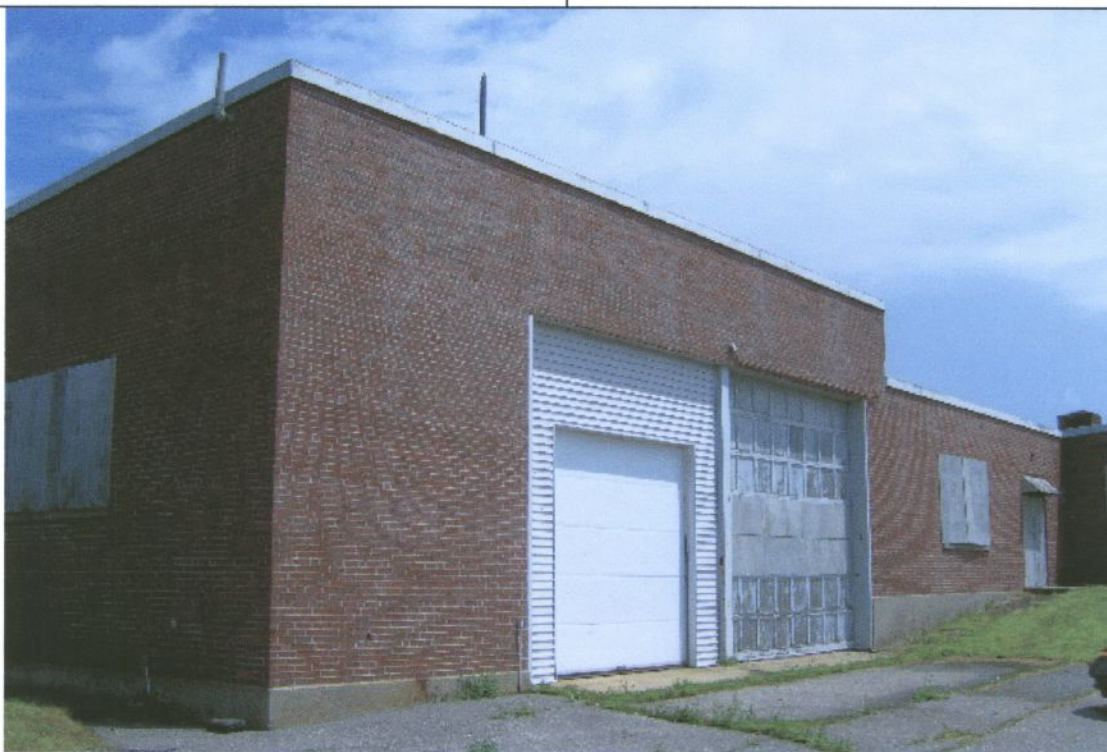
View of Administrative Building #126, Lower Tank Farm area.

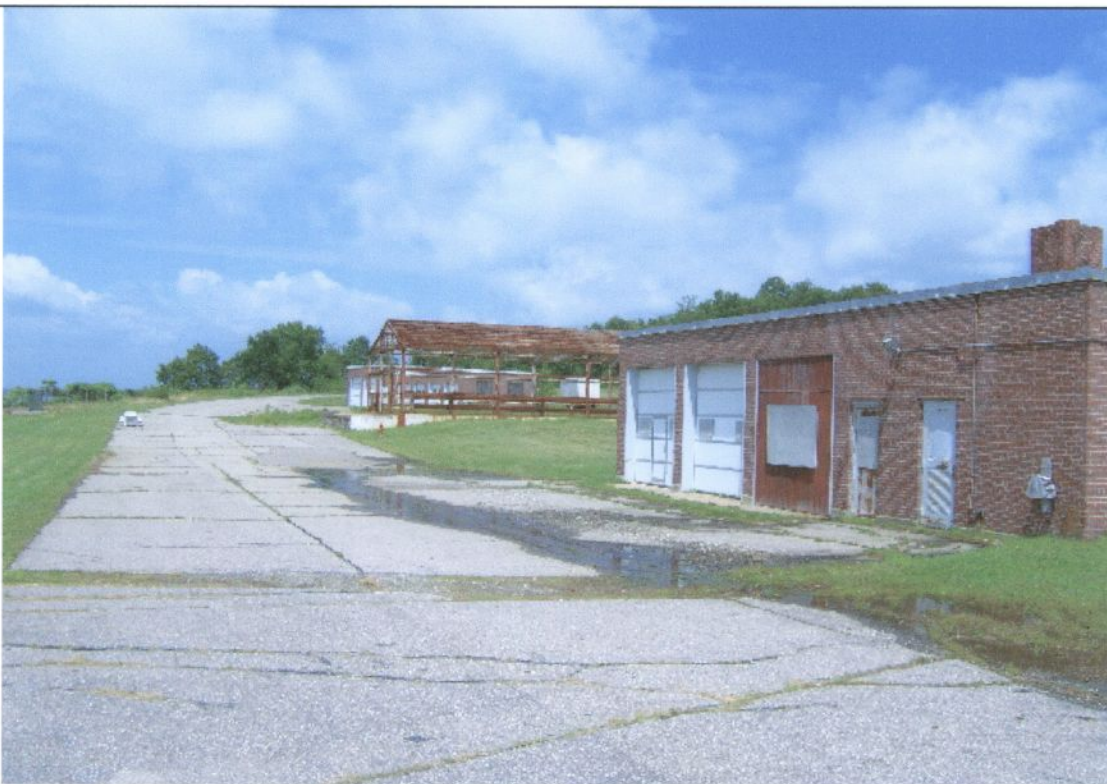
**Photo No. 2**

Roadway along perimeter of Lower Tank Farm; Buildings #158, #130, #129.

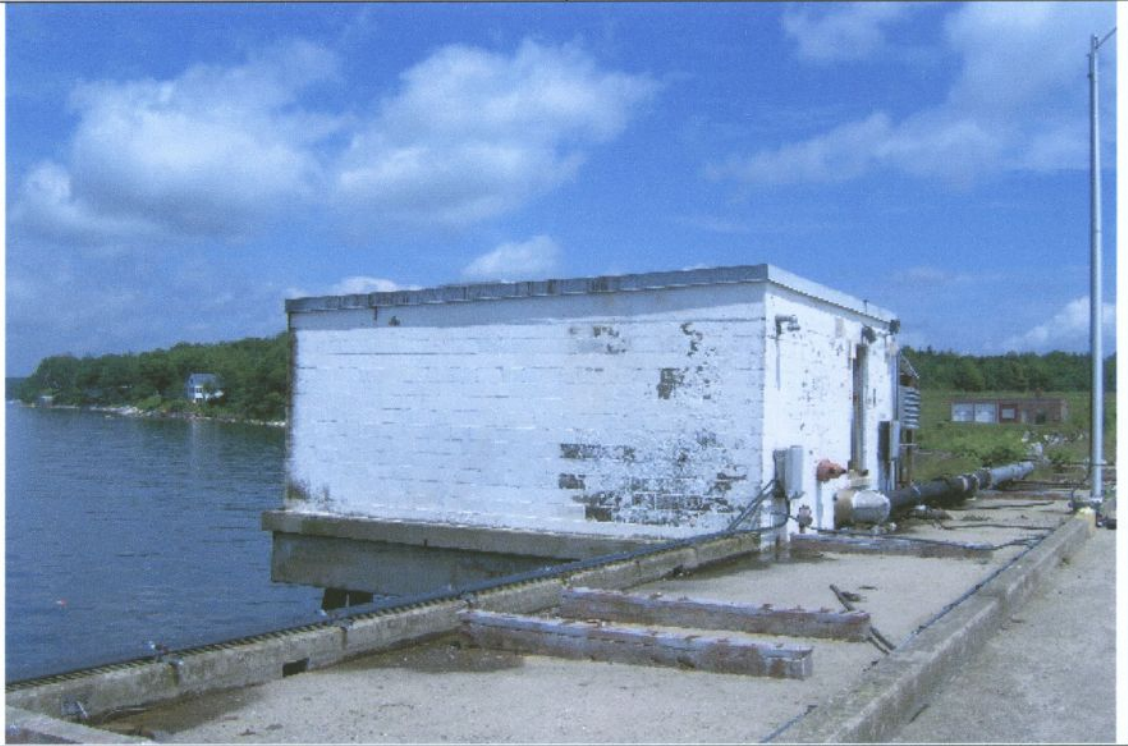
View of Pier Pump House #175.

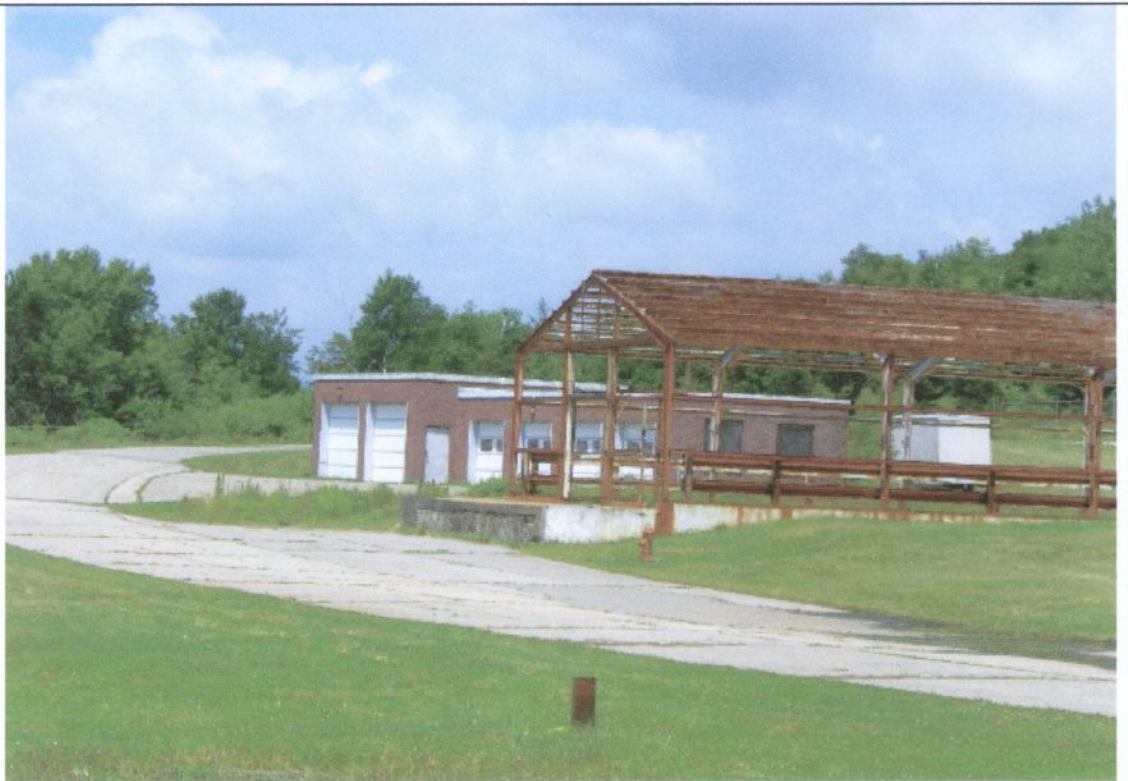
**Photo No. 4**

Four buildings were observed in the former lower tank farm area on the northern portion of the Site. One of these buildings (storage building #130) has been partially demolished with only its metal frame and foundation remaining. Three other one-story, flat-roofed, brick buildings were observed on this portion of the Site, and are known as Administrative Building #126, Garage #158 and Maintenance Building #129. Doors to these buildings were locked, which prevented visual inspection of the interior of the buildings. Two structures are located on the pier: the Pier Pump House #175 and the Pier Checker House #167. Other Site buildings include the Foam House #200, located on the upper tank farm, and the Generator Building #159, located in between the upper and lower tank farms. According to a 2006 survey of Site buildings, some of these buildings are used for storage purposes by the Town of Harpswell.

Frame of Storage Building #130, Garage #158.

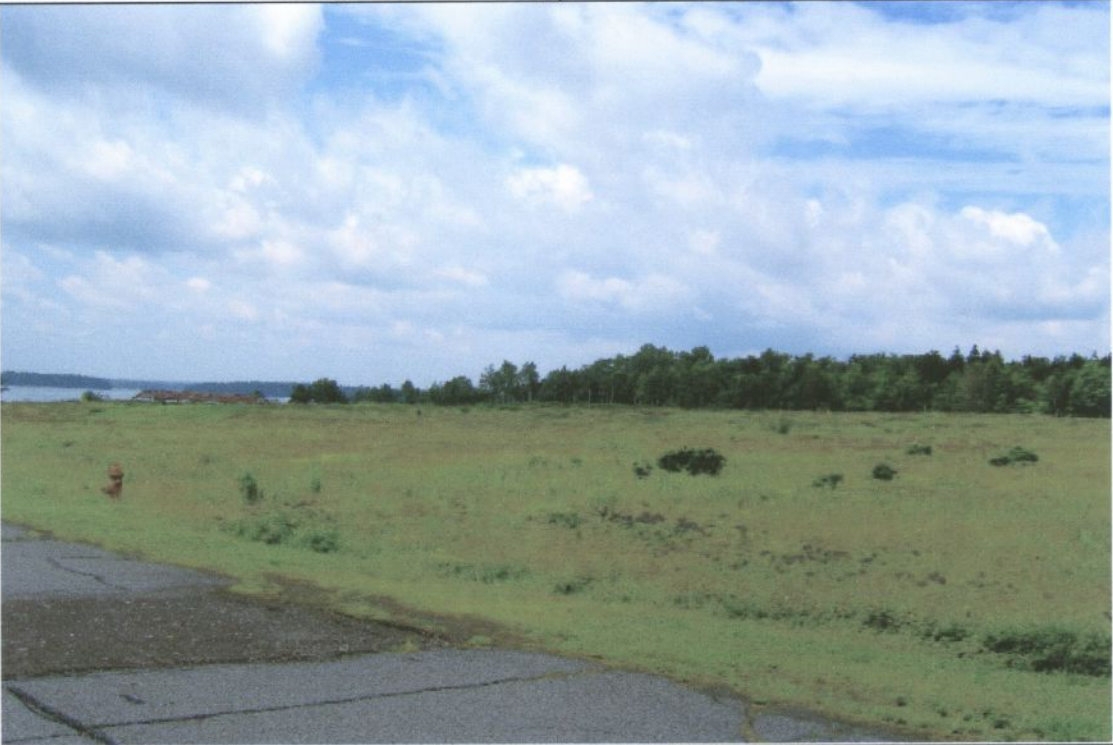
| <b>Photo No. 9</b> | | |

| <b>Description:</b><br><br>Looking north at Lower Tank Farm area | | |

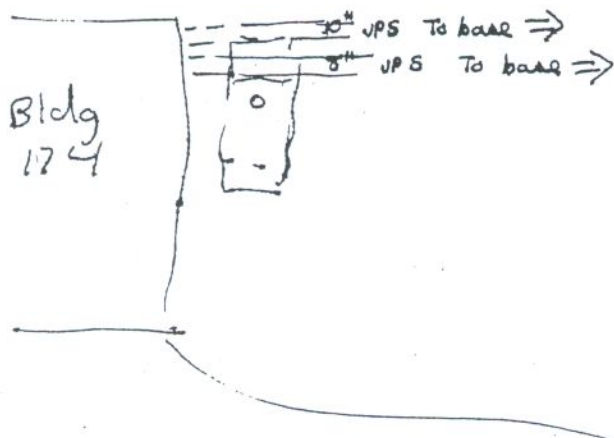
Tank 11 buried 2' deep,  
some prod. spilled w/  
removal

Tank 4, some contam

By Bldg 174, Tank 2 Free product in hole with excavation  
old male/female pipe. Slope tanks  
w/ corrosion holes
